REPORT OF INVESTIGATION

Fatal Machinery Accident
July 7, 2006

General Mine Contracting, Inc. (BSI)
Henderson, KY

East Volunteer
Hopkins County Coal, LLC
Madisonville, Hopkins County, KY
ID No. 15-02013

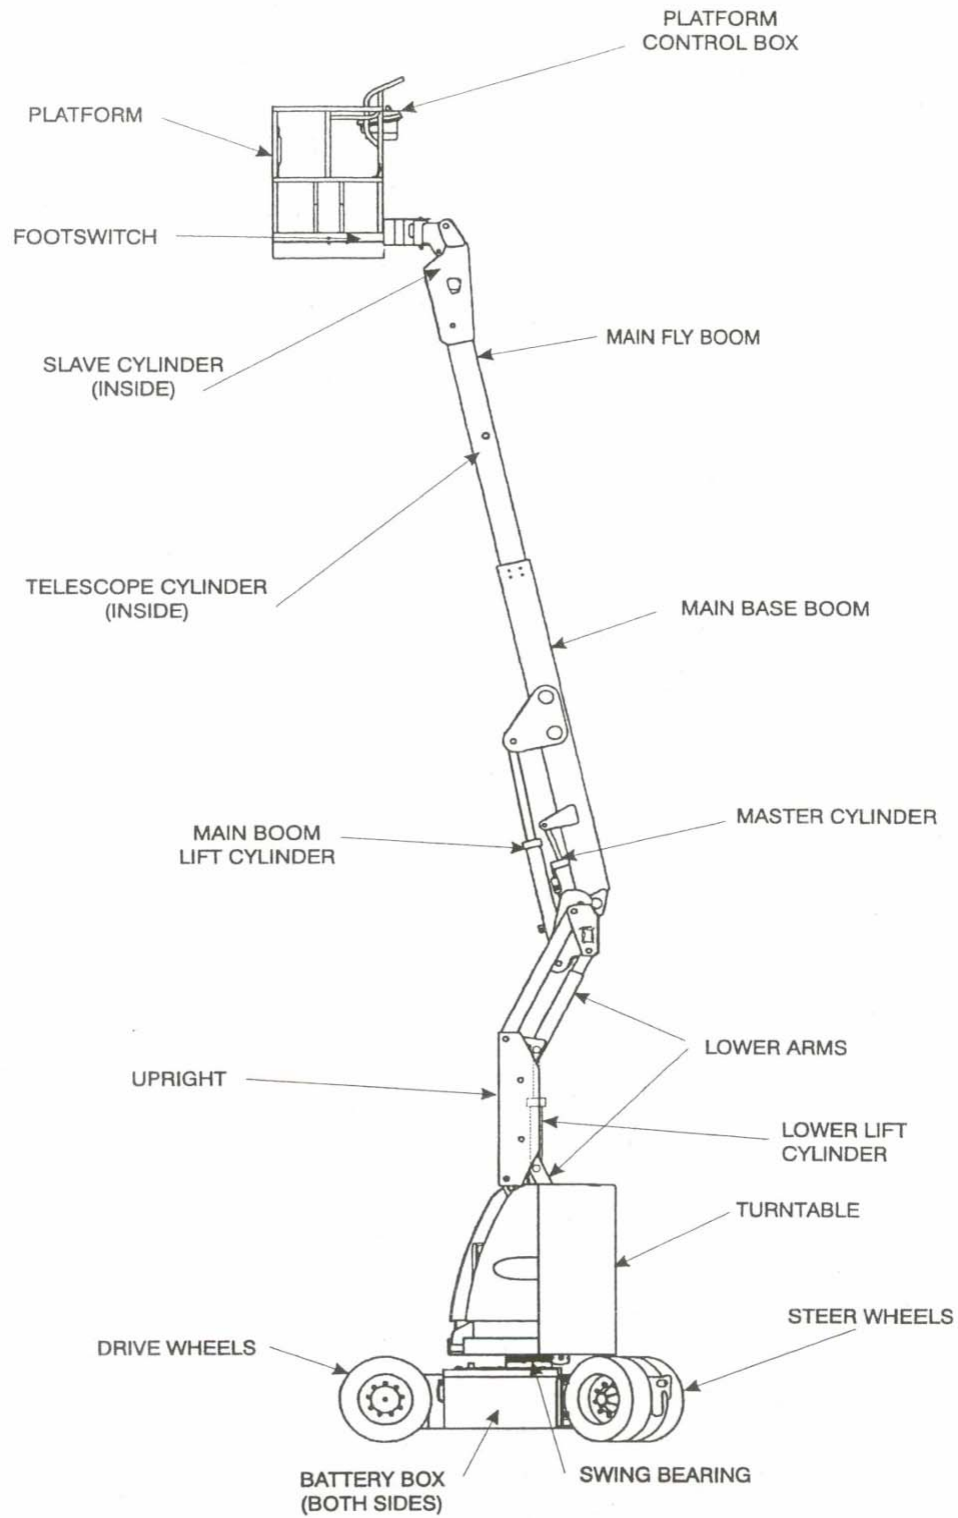
Appendix B Machine Components

The battery powered JLG manlift had a rigid frame with a 360 degree non-continuous rotating turntable. The manlift is rated for a 500 pound capacity at a 30 feet maximum extension. The manlift had non-steering powered front wheels and non-powered steering rear wheels. The wheels had solid rubber tires suitable for improved surfaces on all four wheels. The rotating turntable had multiple components to control the position of the manlift platform. The illustration in Appendix B shows the machine components configured in the most extended condition.

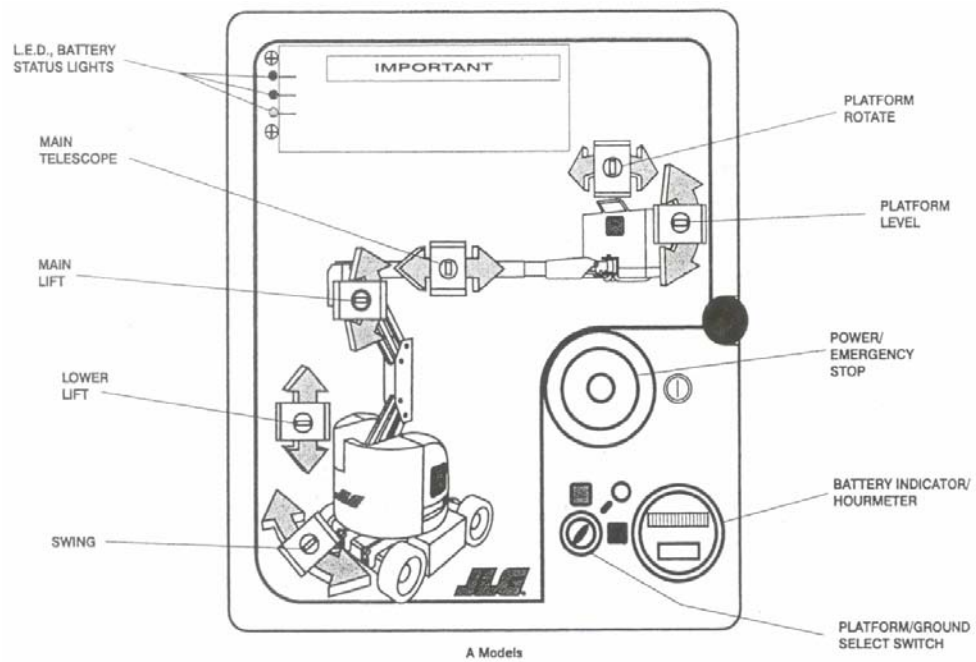
Ground Control Station

The Platform/Ground Select Switch was set to the ground control position. In this position, the upper or platform controls are completely electrically disabled. All control switches were activated, including the emergency stop function during each machine movement. As the controls were activated and released the machine movements would start and stop smoothly. No operational defects were found.

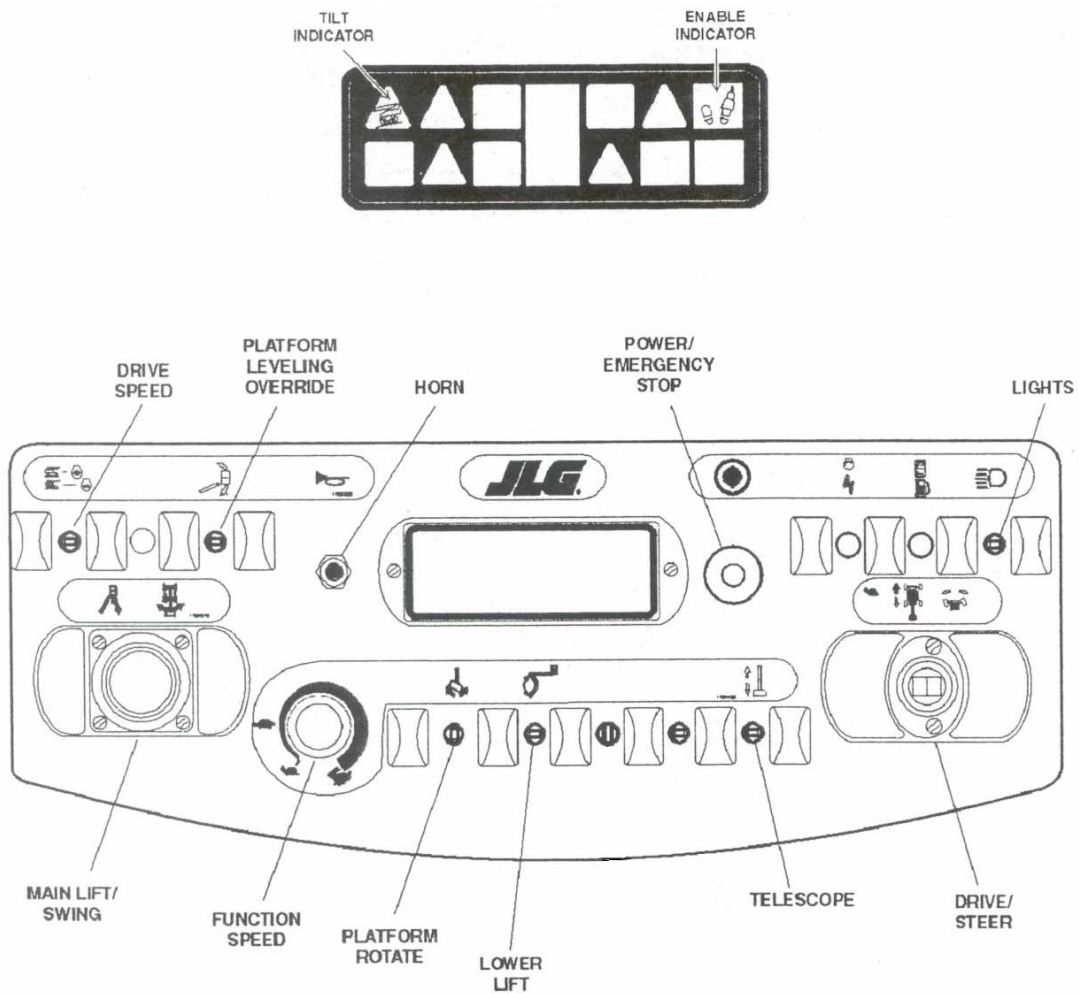
Appendix D Platform Control Station

The Platform/Ground Select Switch was set to the platform control position. In this position, the lower or ground controls are completely electrically disabled. All control switches were activated, including the emergency stop function during each machine movement. As the controls were activated and released the machine movements would start and stop smoothly except for the boom telescope function. No other machine performance defects were found.

The telescope control function required further evaluation and testing. During the initial operational testing, it was noted that the boom would retract unintentionally when the control switch was manually released. At the time of this operational testing, the boom did not extend unintentionally after manually releasing the control switch. When the other control switches were manually released, the functions would stop. The telescope switch would stick and not return to the off position as it was designed to do according to the service manual. When the telescope switch was manually activated and released, it did not have the crisp spring-loaded return feature as exhibited by the other similar switches on the platform control panel.

The boom telescope (boom extend or retract) function was controlled by an electrical switch. This control switch was a single pole, double throw, center-off, spring-loaded momentary contact toggle switch. This switch was designed to have the boom retract when pushing the switch forward and to extend when pulling the switch rearward. The switch is designed to spring return to the center or off position, breaking the continuity of the electrical circuit, when it is released. When manually released during testing, the boom telescope switch would not consistently return to the center or off position and the continuity of the circuit was not broken.

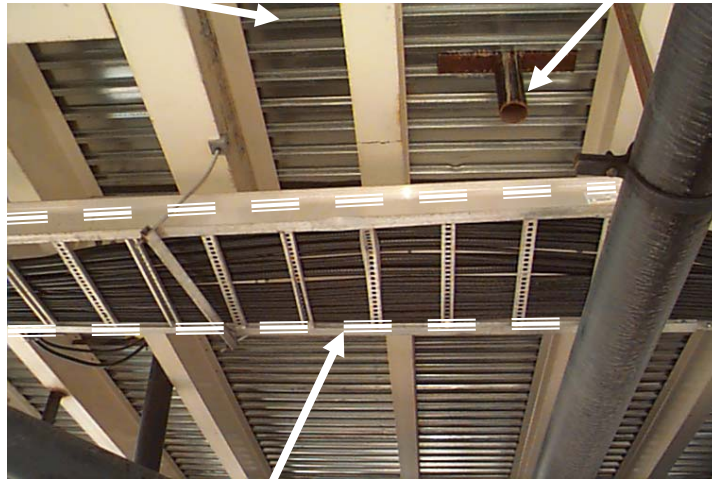
Wide Angle View of Cable Tray

Bottom of 2nd floor

4" Floor Drain

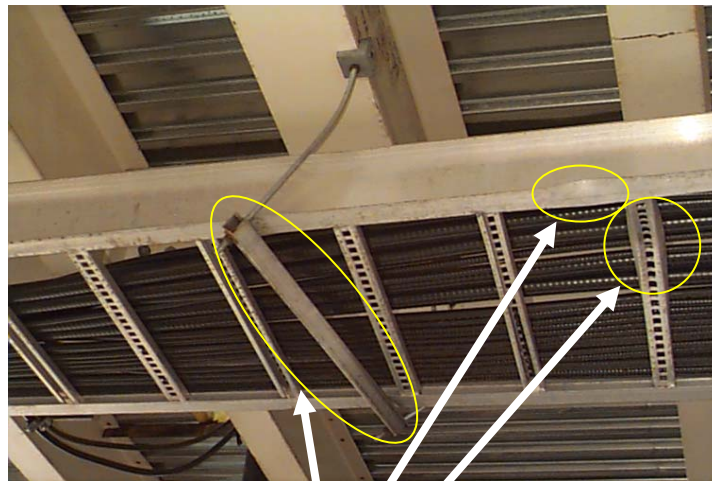
Zoomed View of Cable Tray

Points of Contact

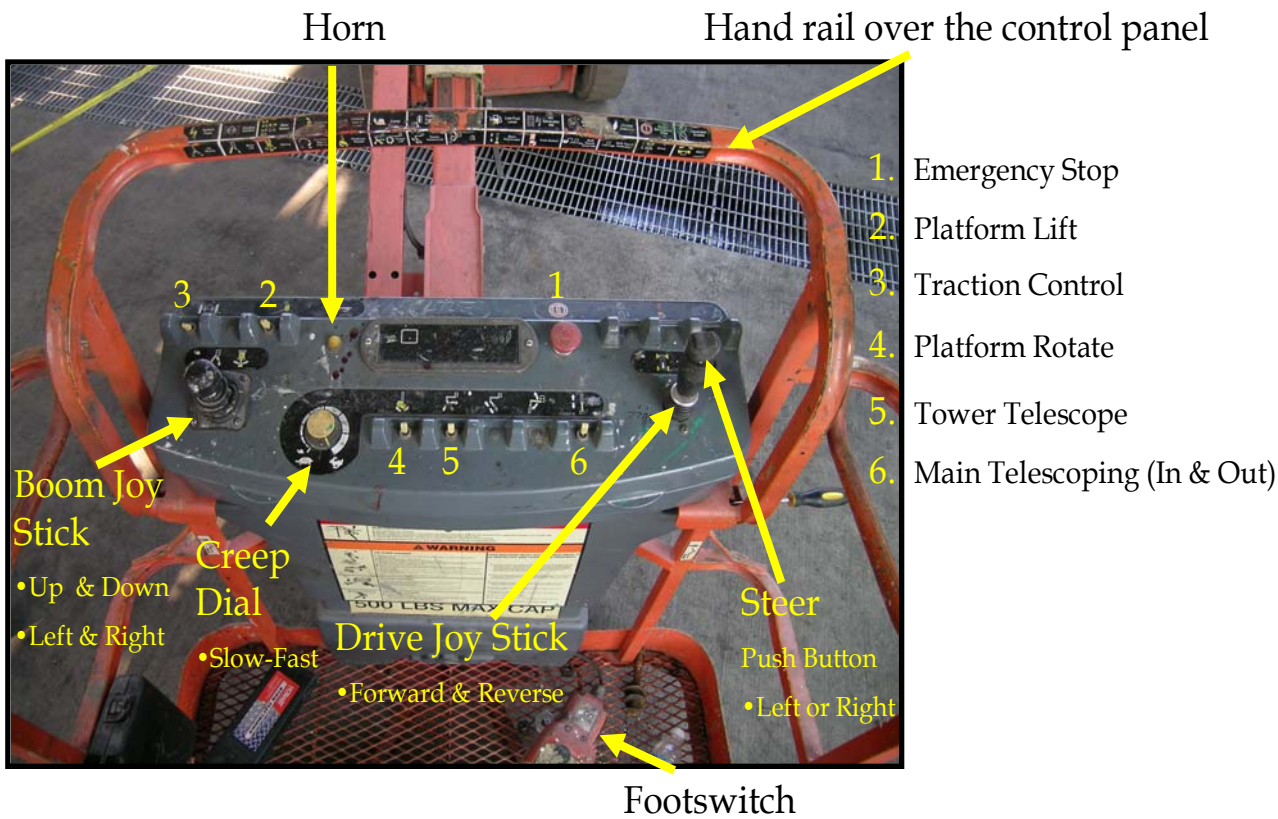
JLG PLATFORM CONTROL PANEL

At the time of the accident, the JLG Lift was not being maintained in a safe operating condition. The main telescoping toggle switch located on the platform control panel was defective in that unintentional movement of the main boom telescope function intermittently occurs.

It should be noted that even though the switch would exhibit intermittent continuity in both switch positions during this continuity testing, during the physical operational testing of the machine, the boom would only retract unintentionally, but not extend unintentionally when manually releasing the switch. A similar switch located near the telescope switch was also tested for continuity in a similar manner and functioned as designed. The intermittent electrical defect in the boom telescope switch had the potential to cause the boom to extend unintentionally after the control was released. The boom telescope switch would operate properly to extend and retract the boom, however, when the switch was manually released, the switch had difficulty in returning to the center or off position in both directions.

104 (a) citation, number 6689310, citing 30 CFR, section 77.404 (a), S & S, Moderate Negligence was issued to East Volunteer stating, "The JLG Lift, Model E300A, serial number 0300055879, was not being maintained in a safe operation condition. The main telescoping switch is defective in that, whenever the switch has been engaged and then is released the boom, at times, continues to telescope either in or out. This condition contributed to the occurrence of this fatal accident."
